**RADIOLOGICAL CHARACTERIZATION REPORT FOR
FUSRAP PROPERTIES IN THE ST. LOUIS, MISSOURI, AREA**

VOLUME I

MARCH 1990

**K. C. Noey
C. M. Sekula
Bechtel National, Inc.
Oak Ridge, Tennessee**

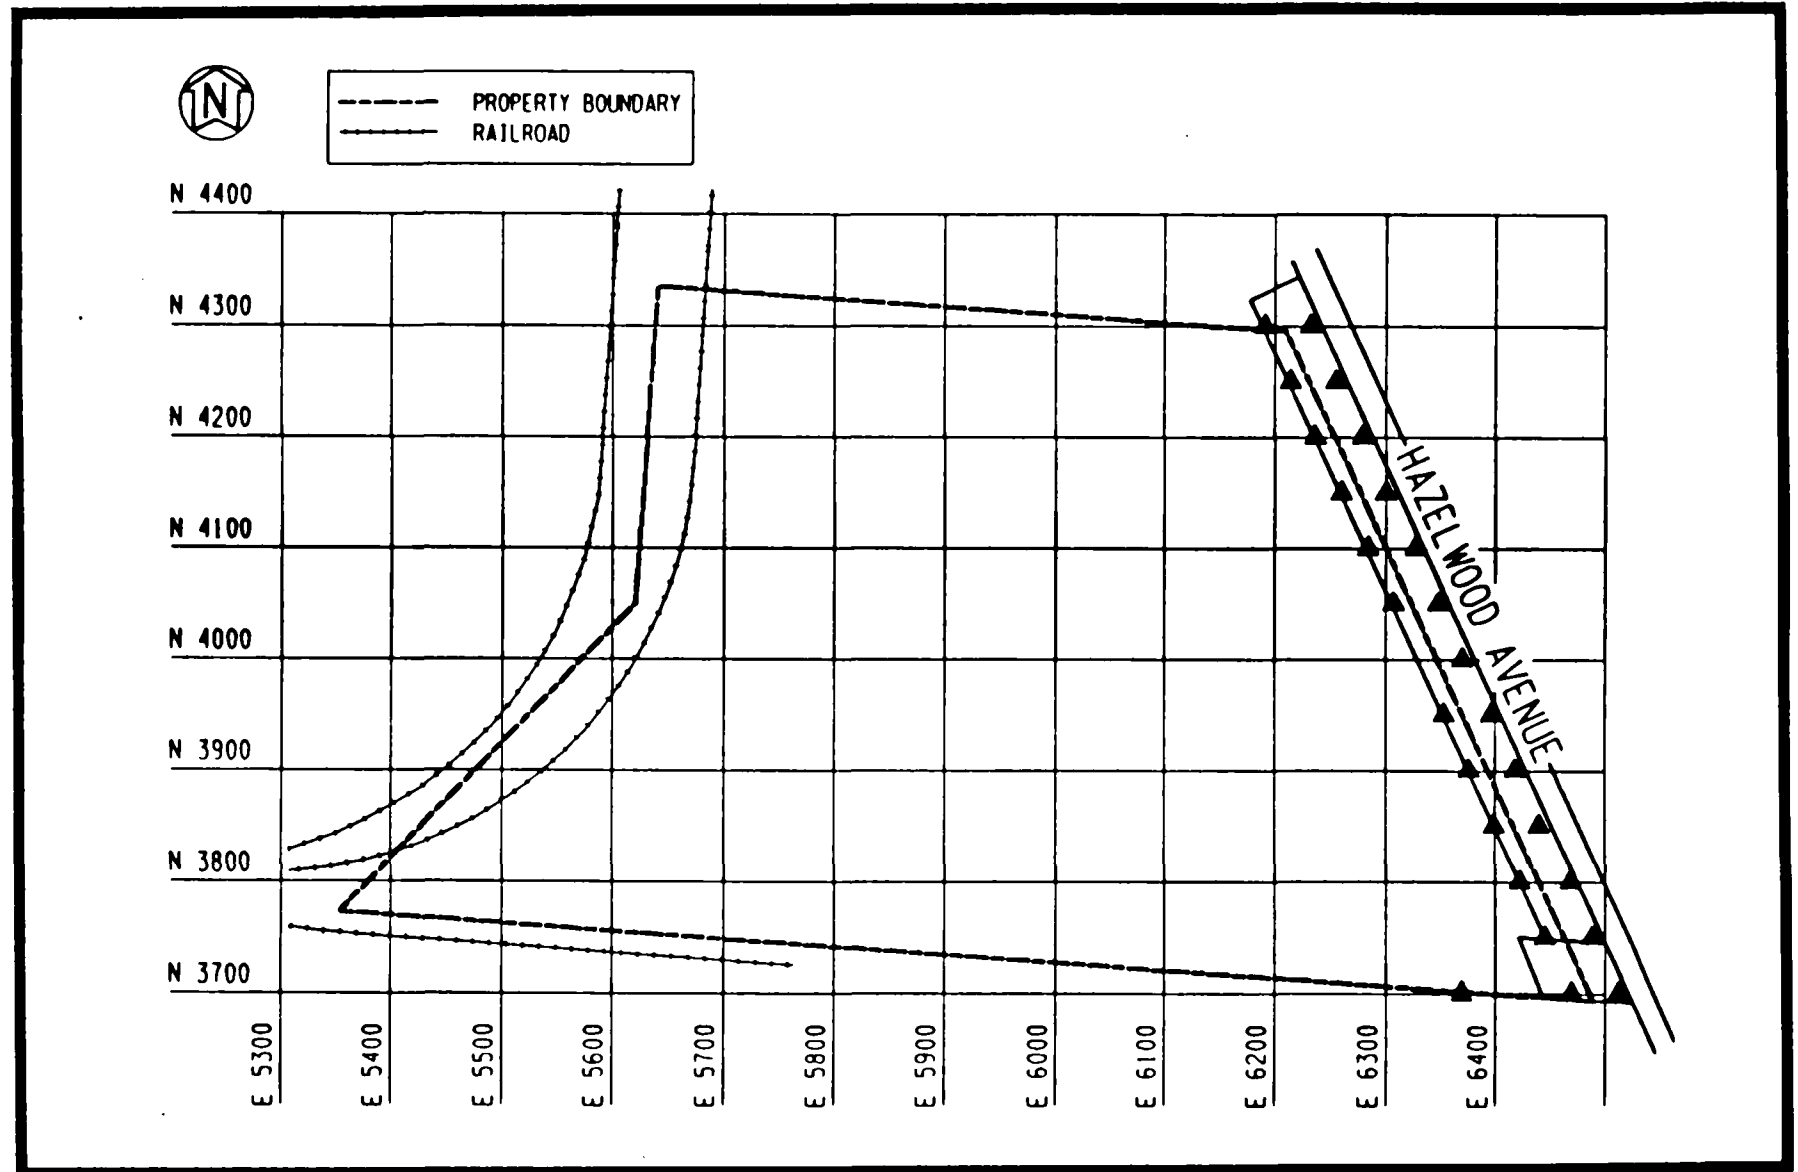
FIGURE 4-11 SOIL SAMPLING LOCATIONS FOR RADIOLOGICAL CHARACTERIZATION OF THE NORFOLK AND WESTERN RAILROAD PROPERTY ADJACENT TO HAZELWOOD AVENUE AND SOUTH OF LATTY AVENUE

In an attempt to determine if thorium-230 contamination existed on the railroad properties adjacent to Hazelwood and Eva Avenues, three parallel rows of hand-augered holes, 1 m (3 ft) deep, at 50-ft intervals, were placed on each property. The first row was at the road's edge, running the length of the property adjacent to Hazelwood Avenue. The second row was on the property, 15 m (50 ft) from the first row. The third row was 30 m (100 ft) from the second row. Locations on this railroad property from which soil samples were collected and analyzed are shown in Figure 4-11. The first row of samples 0 to 30 cm (0 to 1 ft) in depth were analyzed for thorium-230, the primary contaminant, before a determination was made concerning analysis of second and third row samples. If no

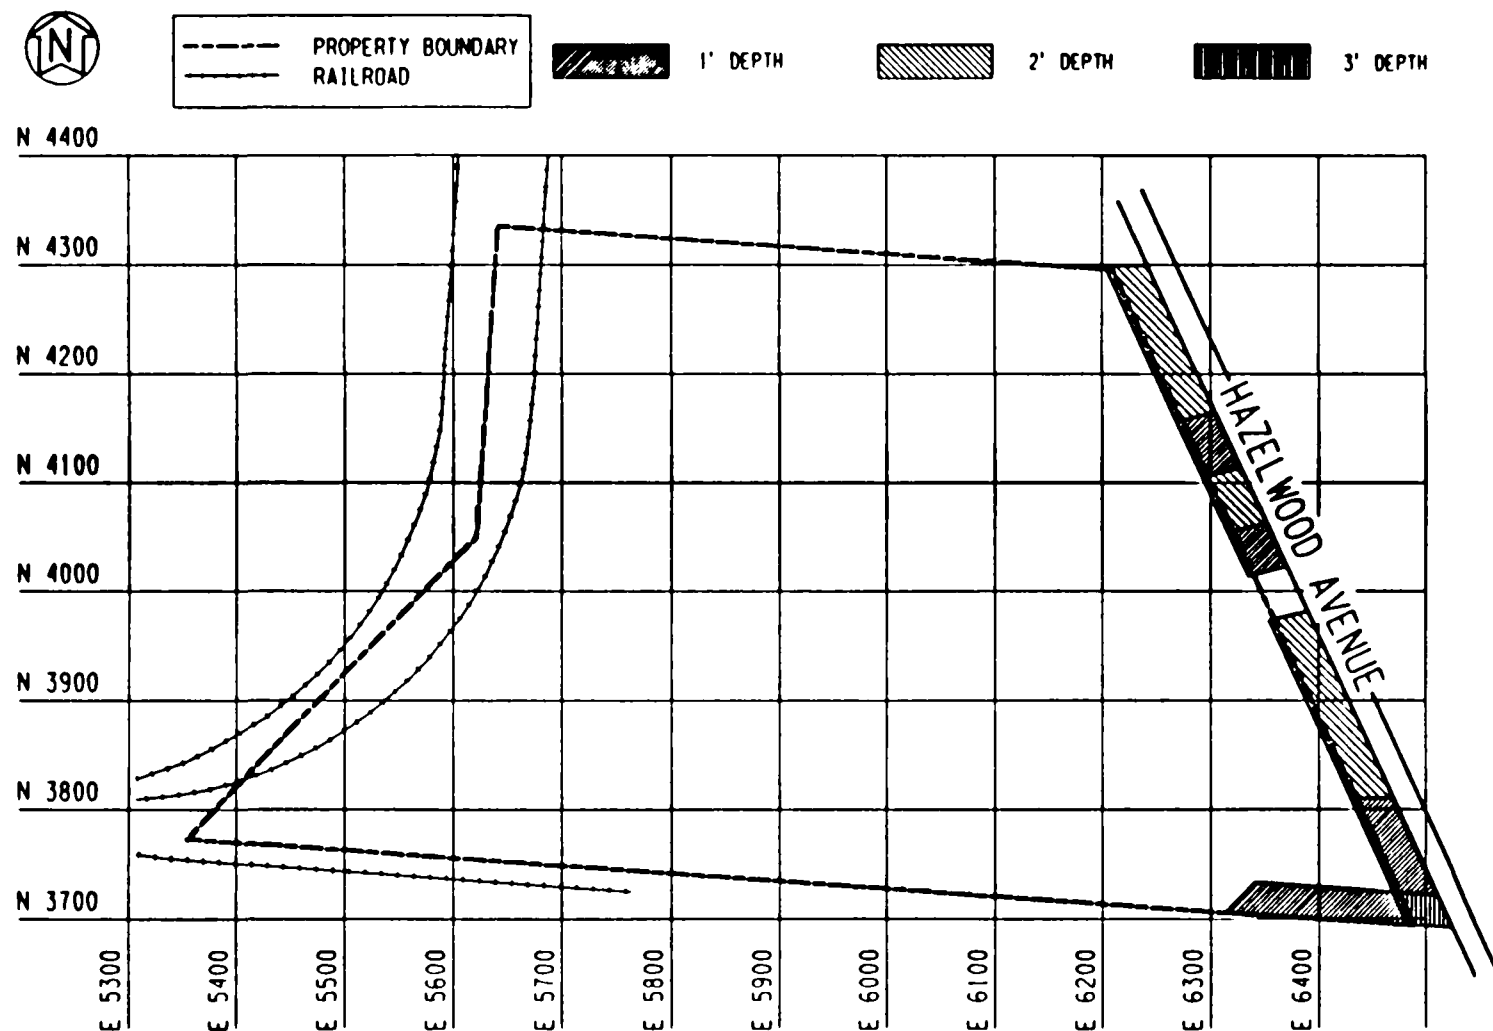
FIGURE 4-12 AREAS AND DEPTHS OF RADIOACTIVE CONTAMINATION AT THE NORFOLK AND WESTERN RAILROAD PROPERTY ADJACENT TO HAZELWOOD AVENUE AND SOUTH OF LATTY AVENUE

Additional soil sampling is required at the railroad property adjacent to Hazelwood Avenue and south of Latty Avenue before all boundaries of radioactive contamination can be established. This sampling will occur prior to remedial action. Figure 4-12 depicts the areas and depths of contamination known to date.

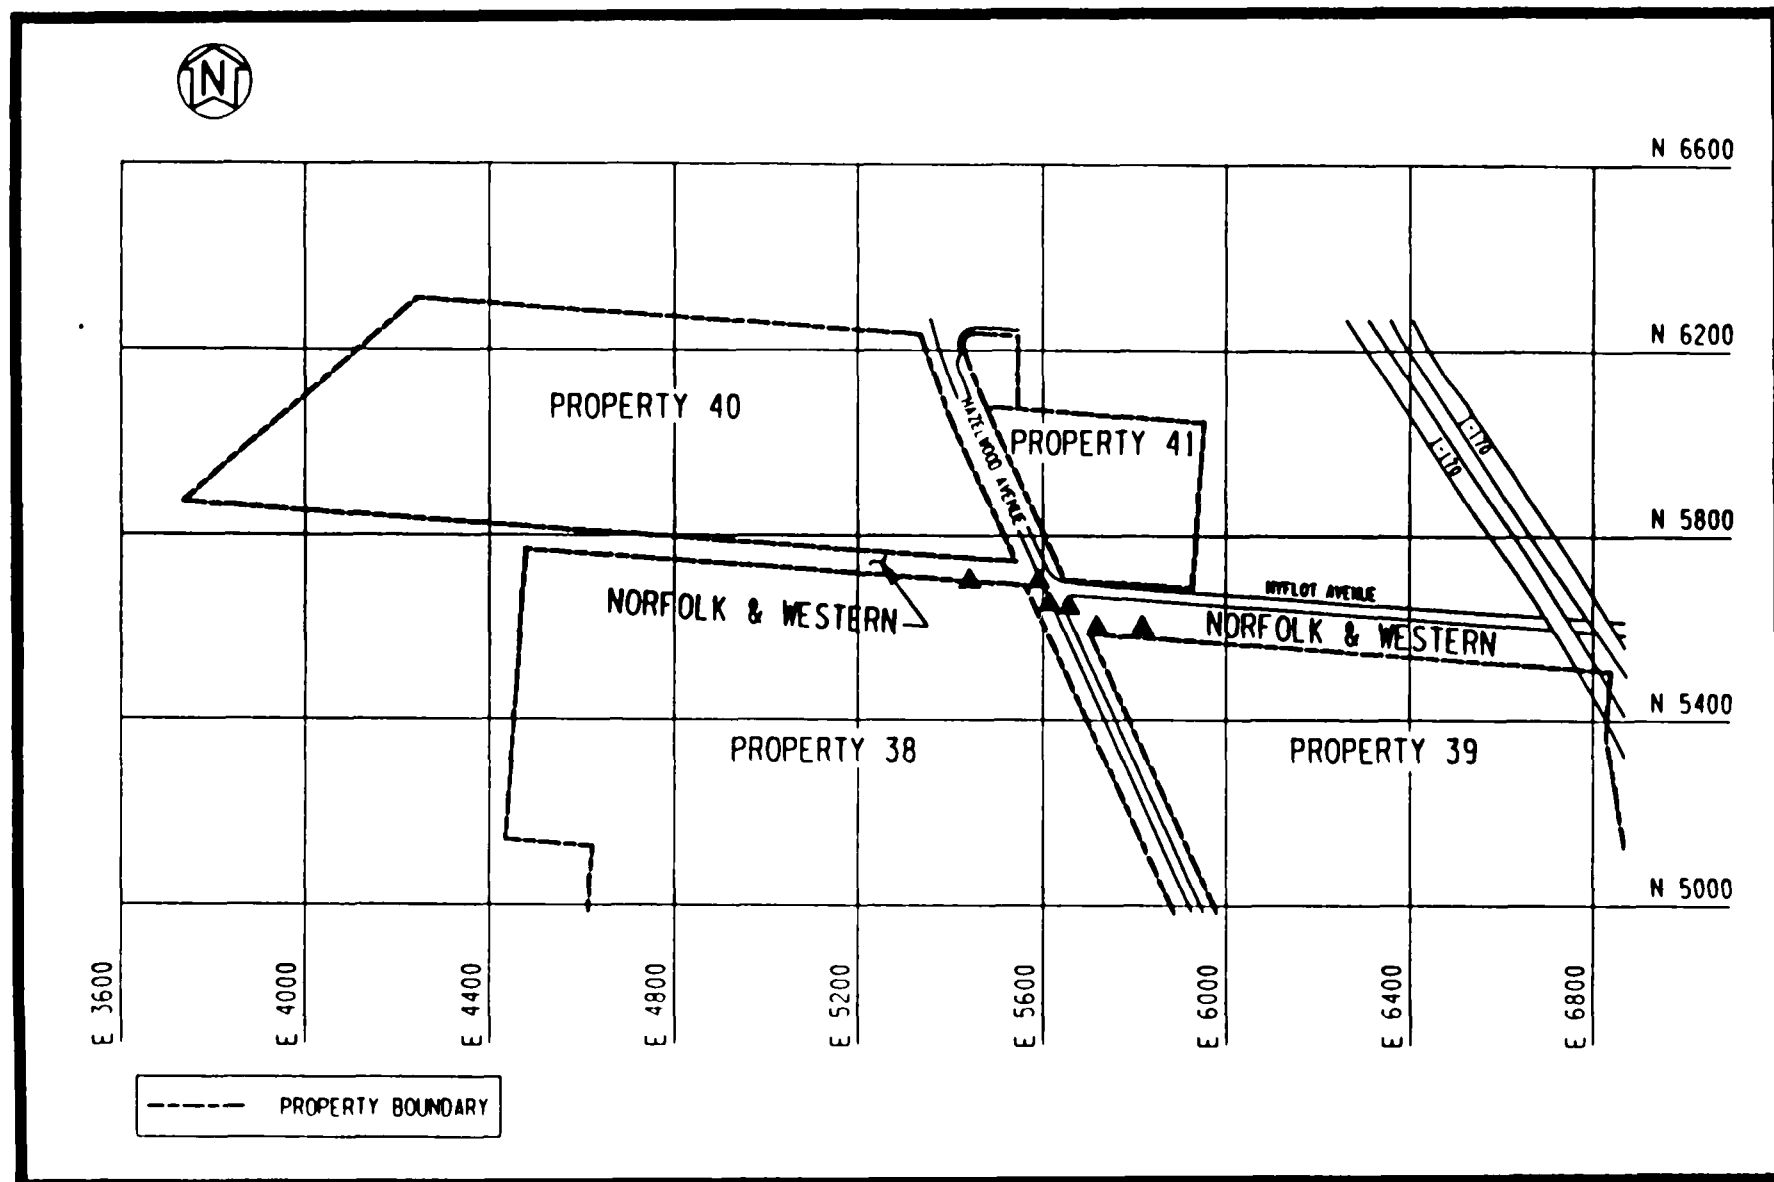
FIGURE 4-13 SOIL SAMPLING LOCATIONS FOR RADIOLOGICAL CHARACTERIZATION OF THE NORFOLK AND WESTERN RAILROAD PROPERTY ADJACENT TO HAZELWOOD AVENUE AND NORTH OF LATTY AVENUE

Six surface soil samples were collected and analyzed for thorium-230 from this property. Soil sampling locations are shown in Figure 4-13. Analytical results for soil (Table 4-11) revealed no areas exhibiting elevated concentrations of thorium-230. Concentrations of thorium-230 ranged from 1.9 to 3.8 pCi/g. Additional soil samples collected and analyzed in this vicinity are shown in Figures 5-79, 5-83 through 5-85, 5-87, and 5-89.

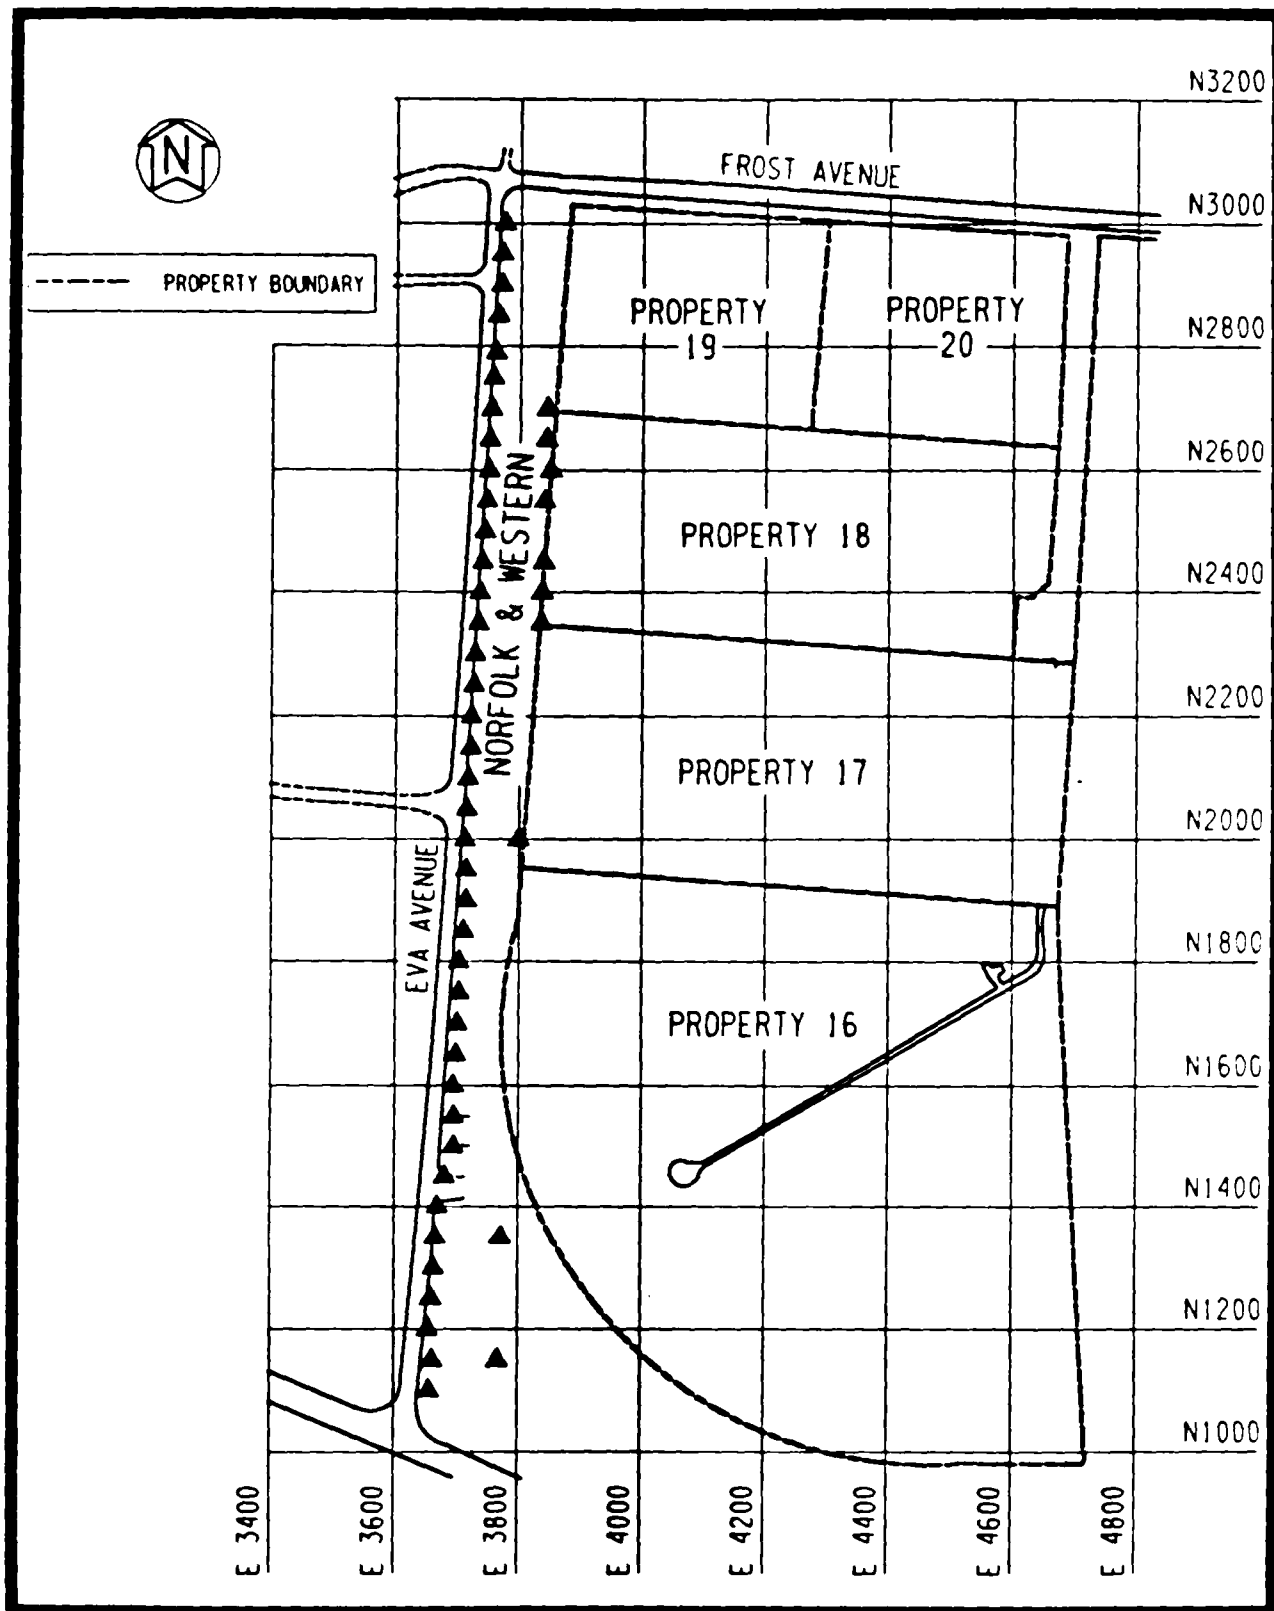
FIGURE 4-14 SOIL SAMPLING LOCATIONS FOR RADIOLOGICAL CHARACTERIZATION OF THE NORFOLK AND WESTERN RAILROAD PROPERTY ADJACENT TO EVA AVENUE

Seventy-two soil samples were collected from the locations shown in Figure 4-14 and analyzed for thorium-230. Additional soil sampling in this vicinity was conducted on adjacent properties, and the locations are shown in Figures 5-38, 5-40, and 5-41. Analytical results for soil (Table 4-12) revealed 23 locations exhibiting elevated concentrations of thorium-230. Concentrations of thorium-230 ranged from less than 0.8 to 85 pCi/g. Figure 4-15 shows areas and depths of contamination at the railroad property adjacent to Eva Avenue.

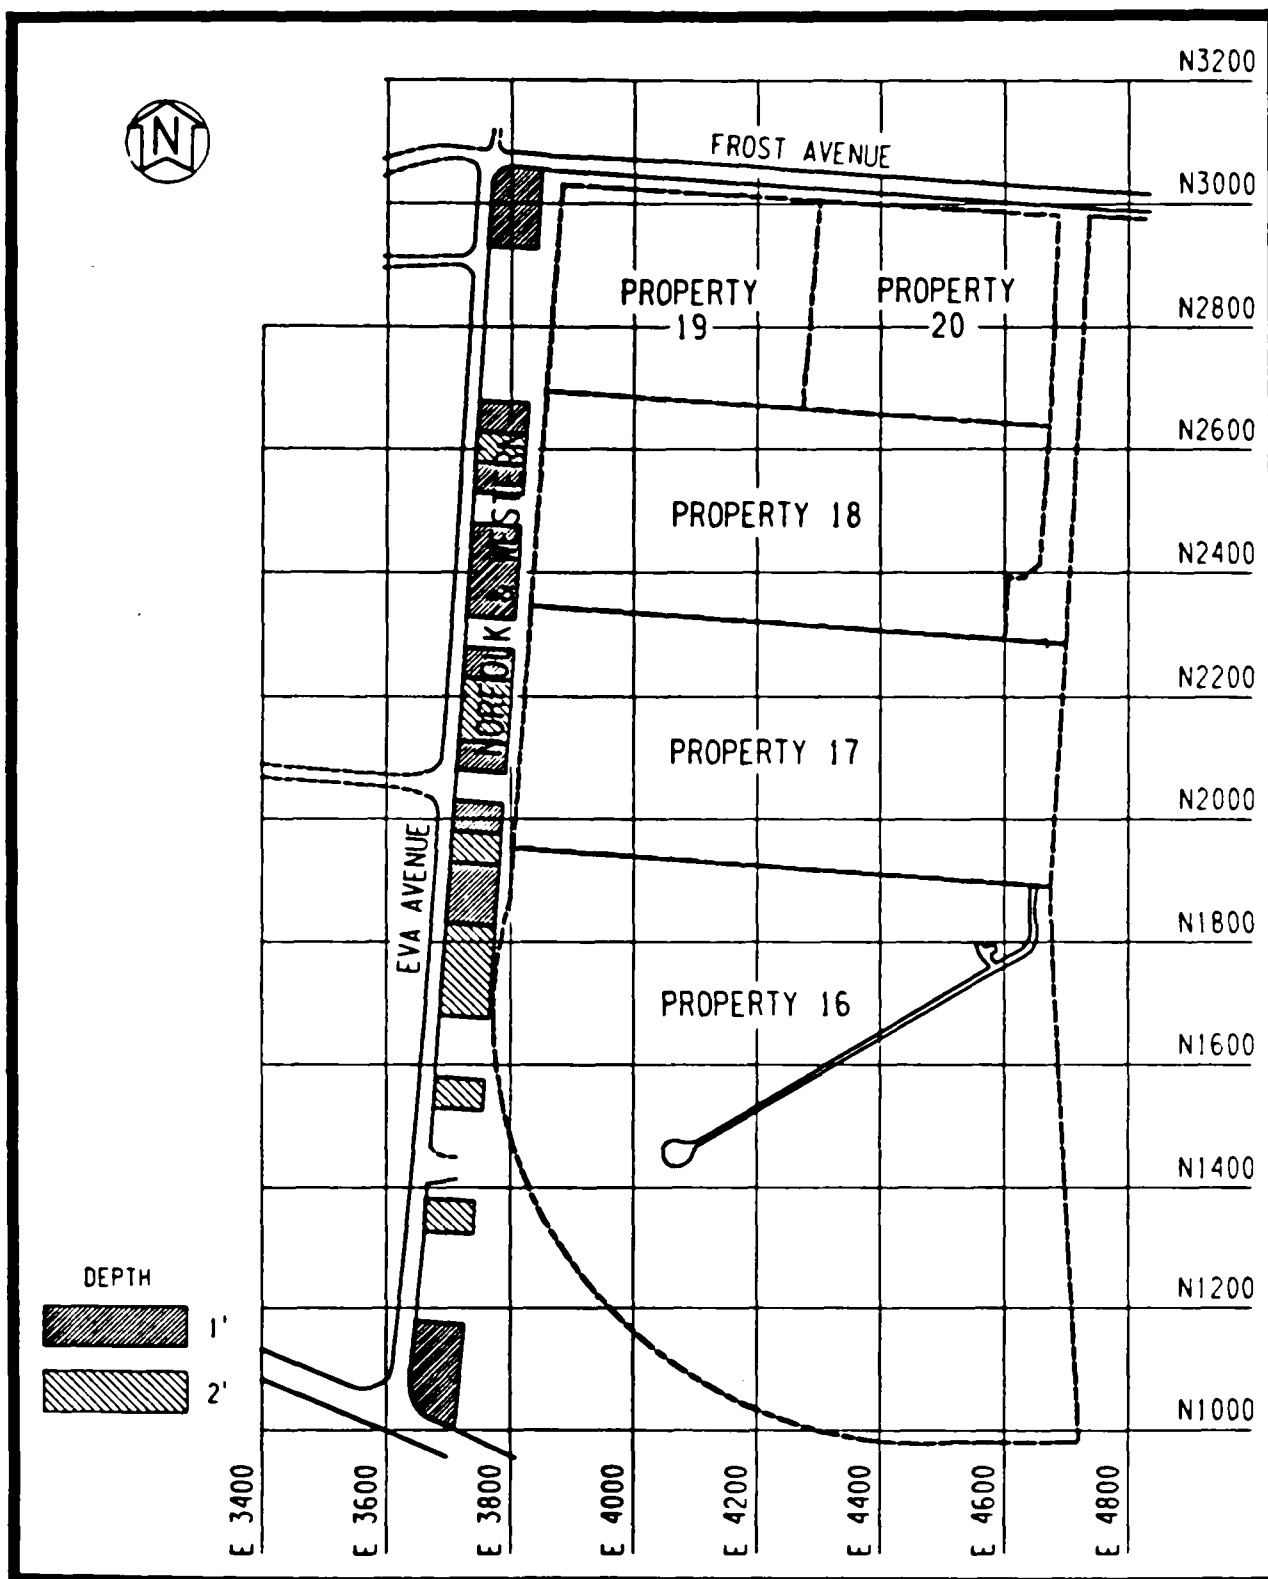
FIGURE 4-15 AREAS AND DEPTHS OF RADIOACTIVE CONTAMINATION AT THE NORFOLK AND WESTERN RAILROAD PROPERTY ADJACENT TO EVA AVENUE

In summary, characterization results from the railroad properties indicate that radioactive contamination is present on all of the properties except for the right-of-way north of Latty Avenue and the property adjacent to Hanley Road. Thorium-230 was identified as the primary contaminant. In general, the contamination is shallow [0.6 m (2 ft)]; a few smaller areas extend to greater depths.

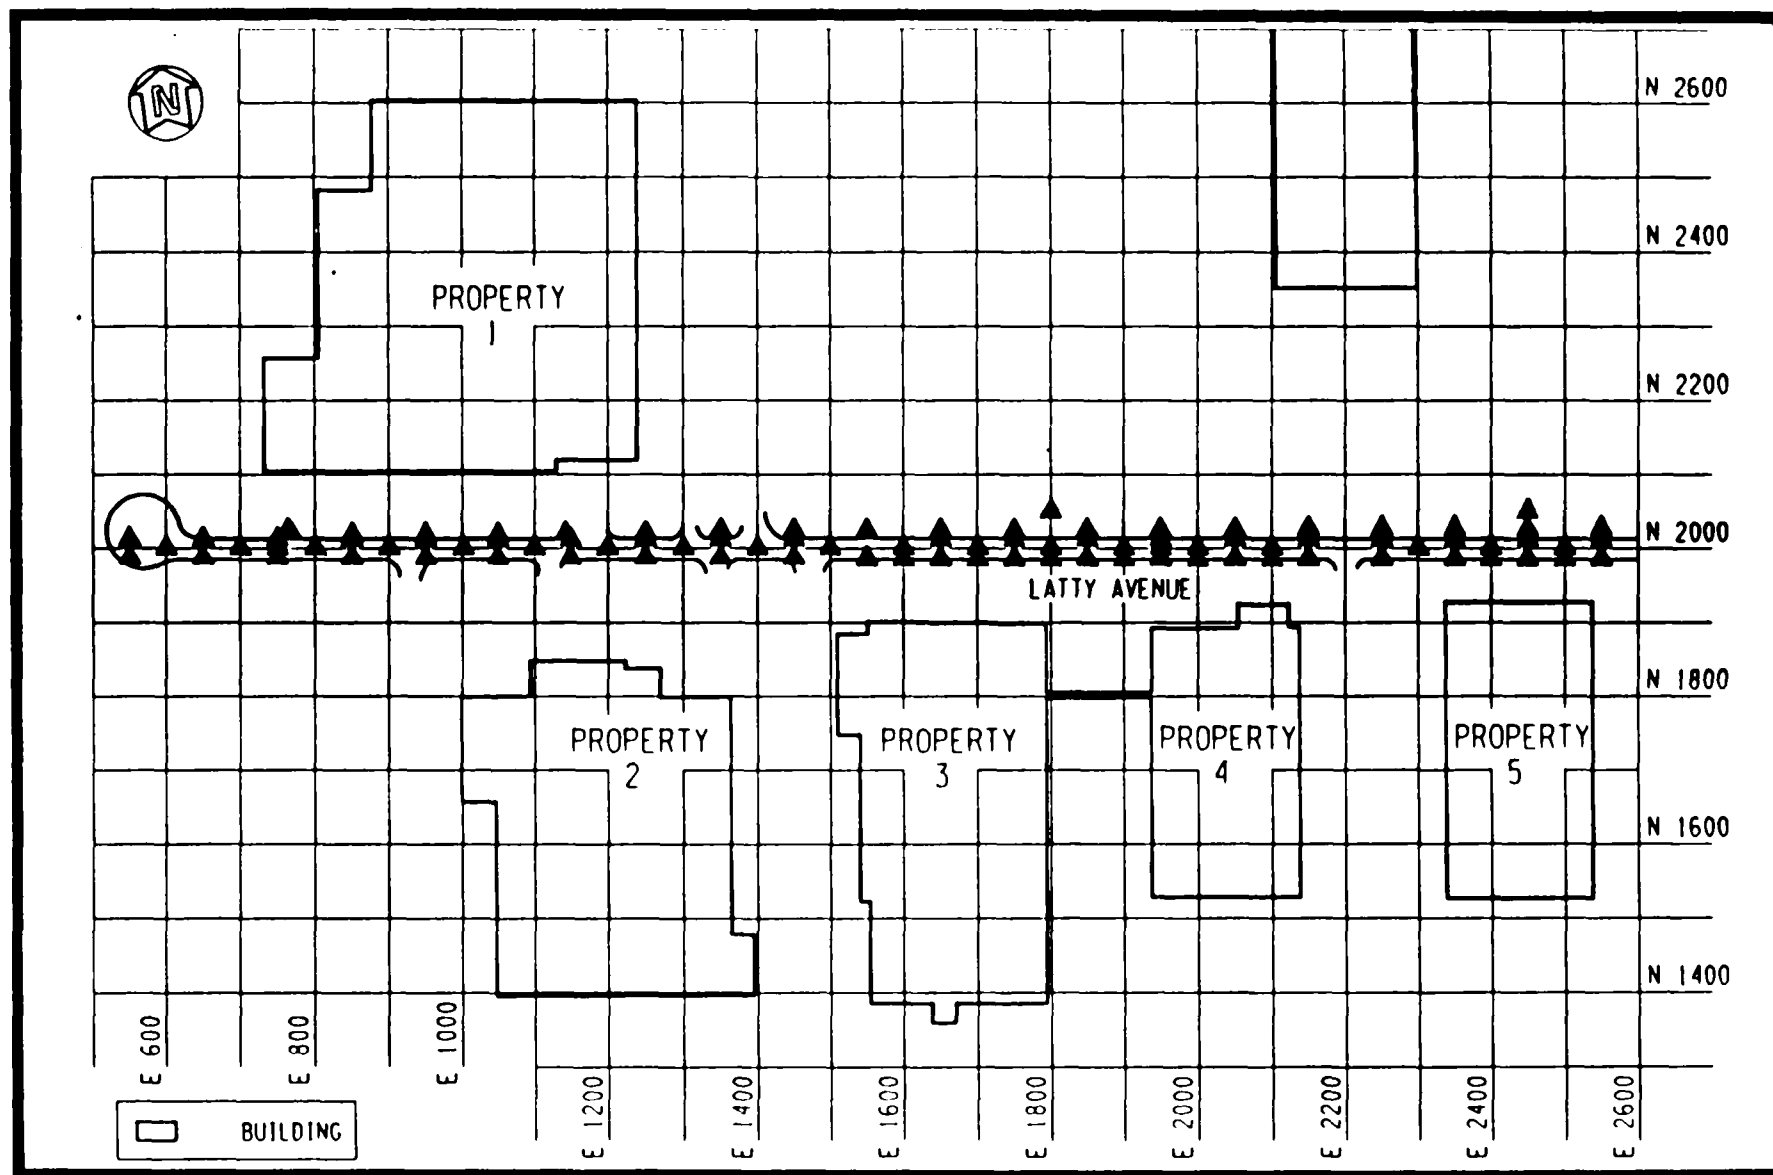
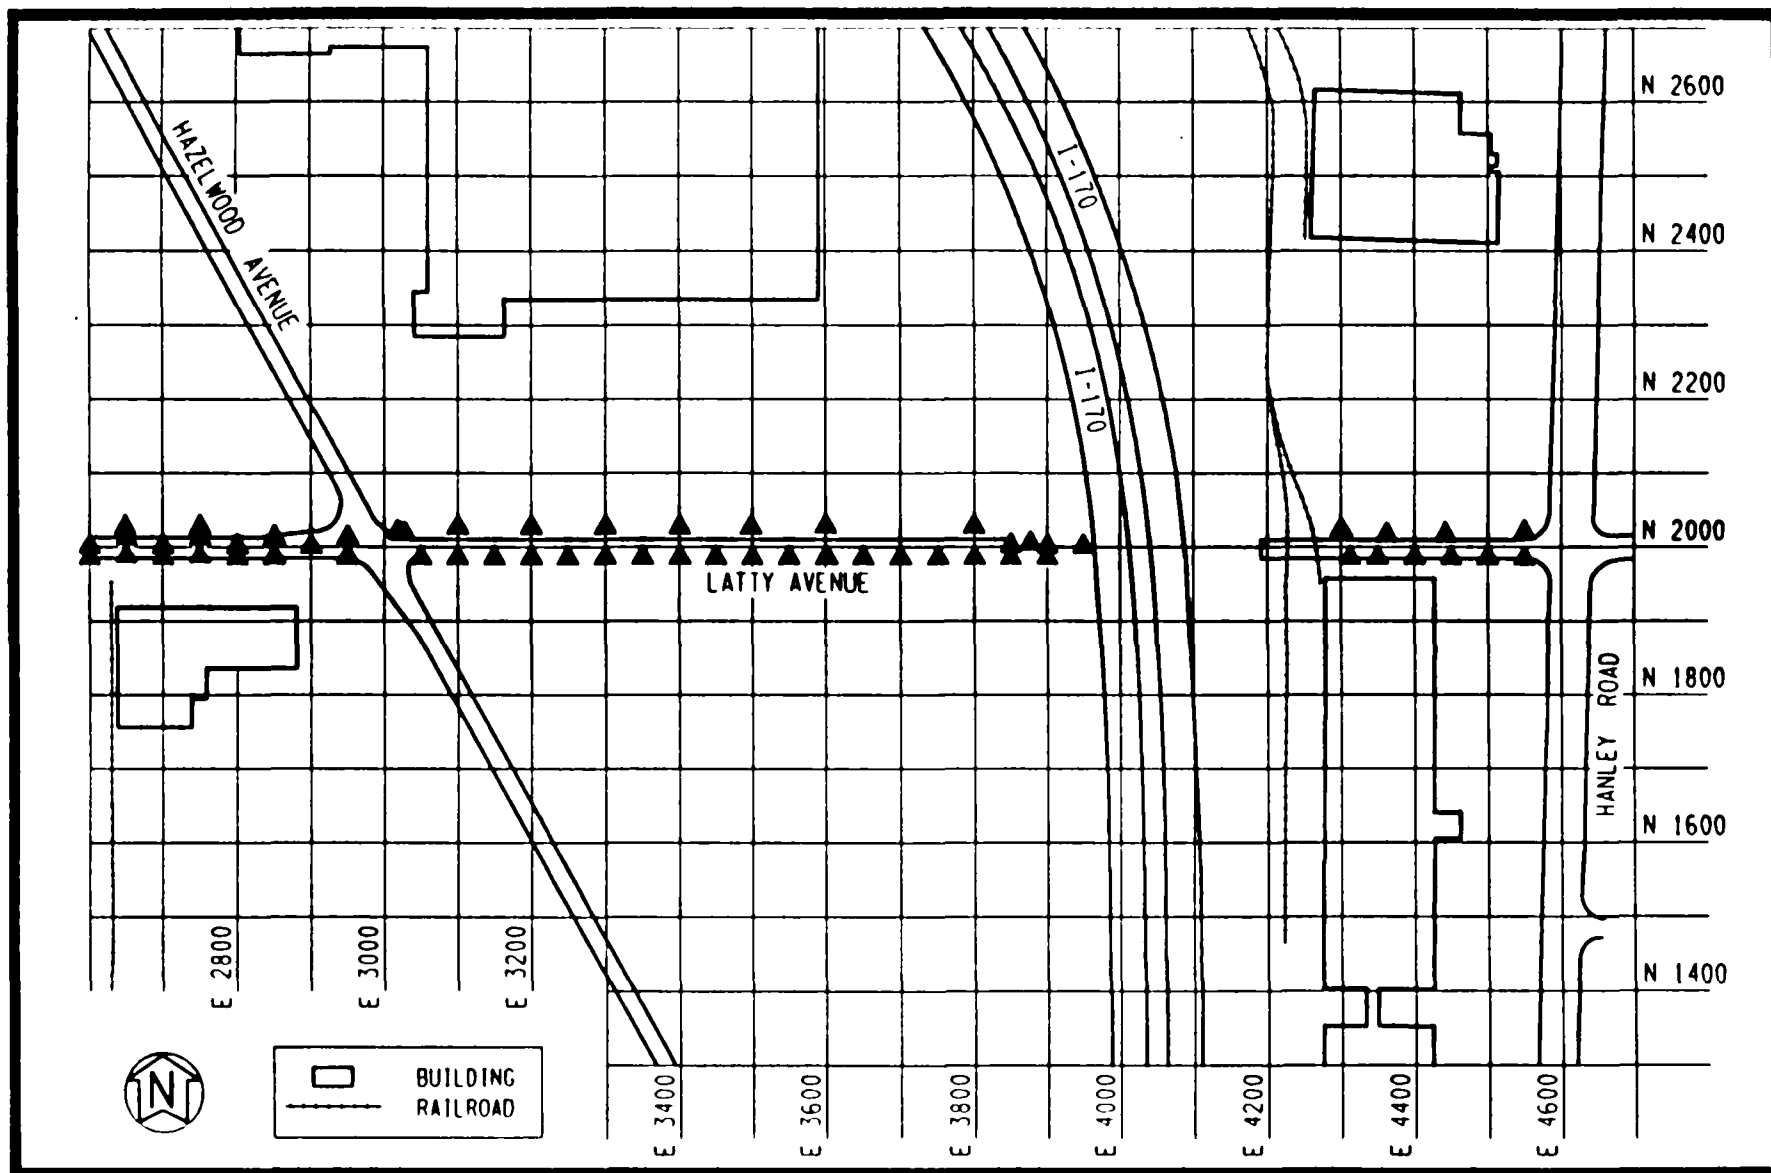
FIGURE 5-1 SURFACE SOIL SAMPLING LOCATIONS FOR RADIOLOGICAL CHARACTERIZATION OF LATTY AVENUE

Soil sampling locations at Latty Avenue are shown in Figures 5-1 and 5-2. Analytical results for soil collected at Latty Avenue (Table 5-2) revealed areas with elevated concentrations of radium-226 and thorium-230 in surface and subsurface samples. Uranium-238 concentrations ranged from less than 3 to 48.2 pCi/g. Radium-226 concentrations ranged from 0.6 to 39.9 pCi/g. Concentrations of thorium-232 ranged from 0.4 to 9.5 pCi/g. Thorium-230 concentrations ranged from less than 0.2 to 1,413 pCi/g. Areas and depths of contamination are shown in Figure 5-3. In most instances, contamination is confined to the surface soil [i.e., 0 to 0.3 m (0 to 1 ft)]. A small area of contamination on the south side of Latty Avenue near Property 37, on the haul roads, extended to a depth of 2.1 m (7 ft).

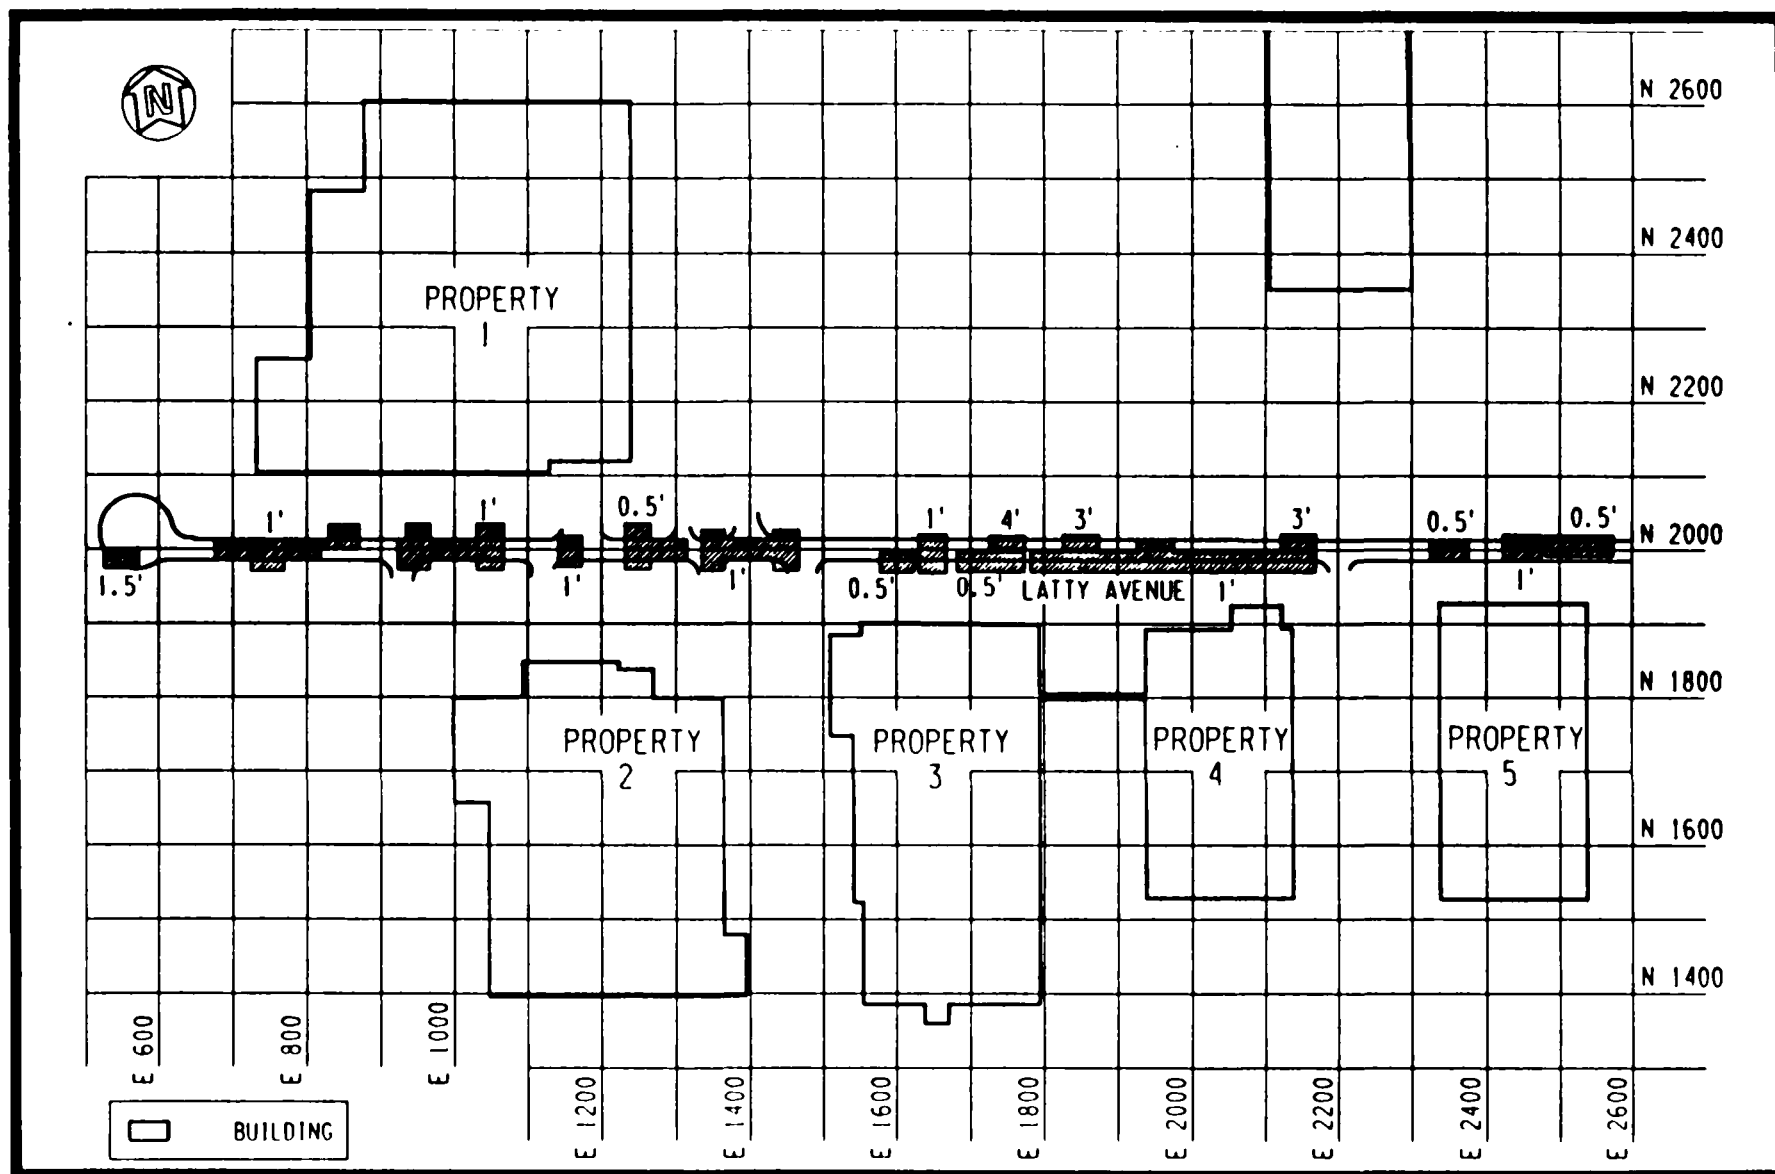
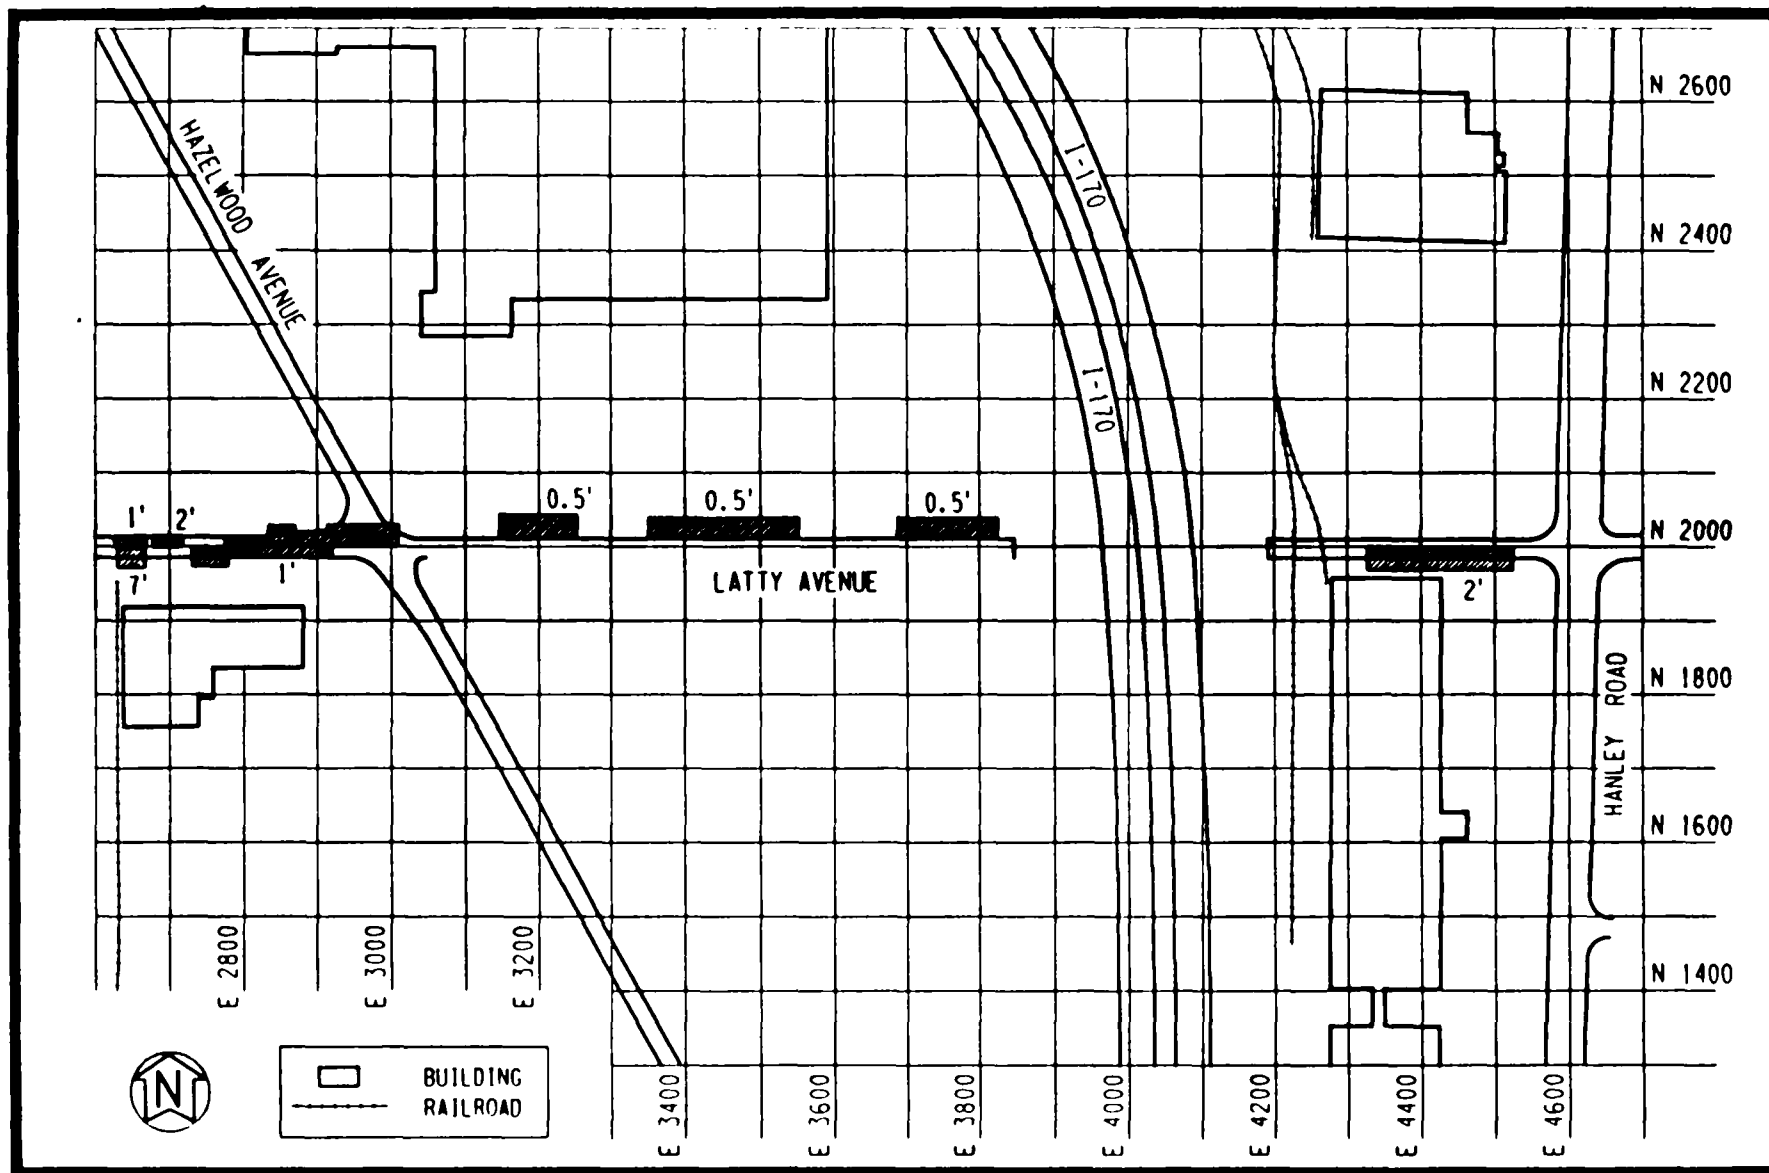
FIGURE 5-3 AREAS AND DEPTHS OF RADIOACTIVE CONTAMINATION AT LATTY AVENUE

Contamination is shown at Latty Avenue, adjacent to Property 39. These areas of contamination are also shown in Figure 5-3 and were determined from the soil sample results collected during the radiological characterization of Latty Avenue.
